| Report ID: | 28,261,367 | Version: | 1 |

| Make: | Toyota | Model: | Hiace |
| Body Style: | Van | Year: | 2014 |

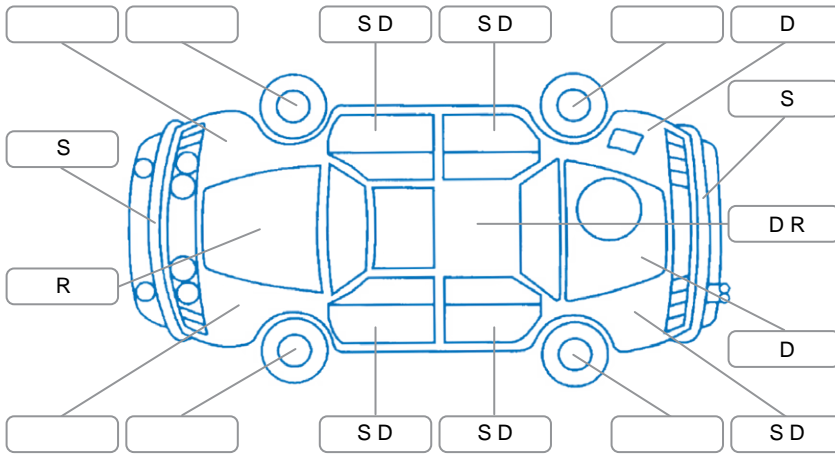
Key
 S = Scratch R = Rust C = Crack * = Decals W = Significant scuffs
 D = Dent PT = Paint defect P = Pin dent SC = Stone Chips

Note: some defects and blemishes may not be displayed in the diagram

Rear tail gate body seal torn, spare tool missing, engine oil leak,
