Report ID:	28,269,625	Version:	1
Created:	23 Jun 2026

Make:	Nissan	Model:	Navara
Body Style:	Utility	Year:	2006
Rego No.:	DFB680	Rego Expiry:	31 Oct 2026
WoF Expiry:	03 Jun 2026	Odometer:	328,203 Kms
Good No.:	28269625	VIN:	VSKCVND40A0071643
Next Service:	330000	Service History:	No

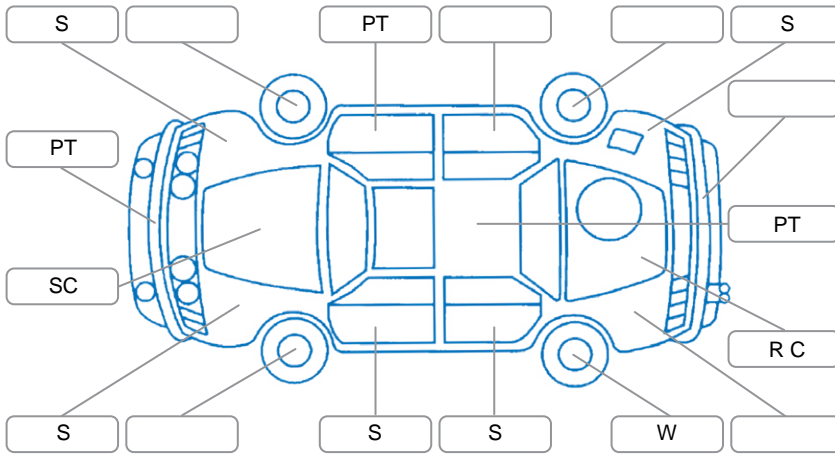
Key
 S = Scratch R = Rust C = Crack * = Decals W = Significant scuffs
 D = Dent PT = Paint defect P = Pin dent SC = Stone Chips

Note: some defects and blemishes may not be displayed in the diagram
