Report ID:	28,271,464	Version:	3
Created:	22 Jun 2026

Make:	Mitsubishi	Model:	RVR
Body Style:	SUV	Year:	2014
Rego No.:	MQN549	Rego Expiry:	01 May 2026
WoF Expiry:	08 Apr 2026	Odometer:	188,600 Kms
Good No.:	28271464	VIN:	7AT0CJ1KX19400486
Next Service:	198,000 Kms	Service History:	No

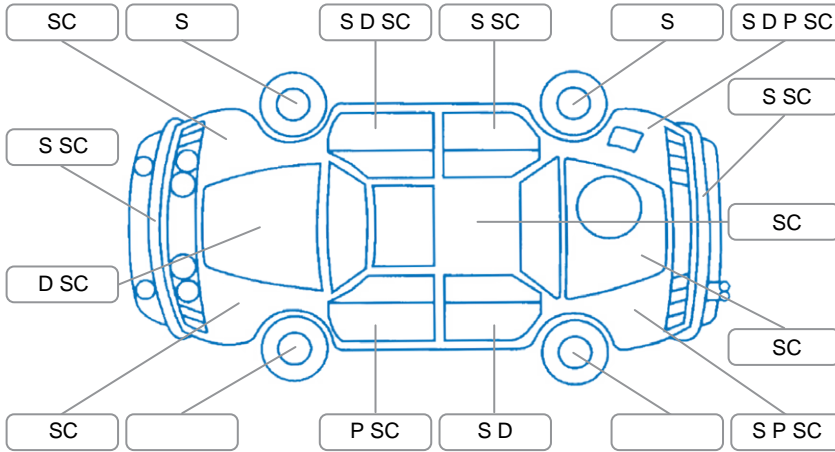
Note: some defects and blemishes may not be displayed in the diagram

Front bumper lower grille cracked.  
 RF sill step plate worn.
