| Report ID: | 28,277,015 | Version: | 1 |

| Make: | Holden | Model: | Captiva 5 |
| Body Style: | SUV | Year: | 2013 |

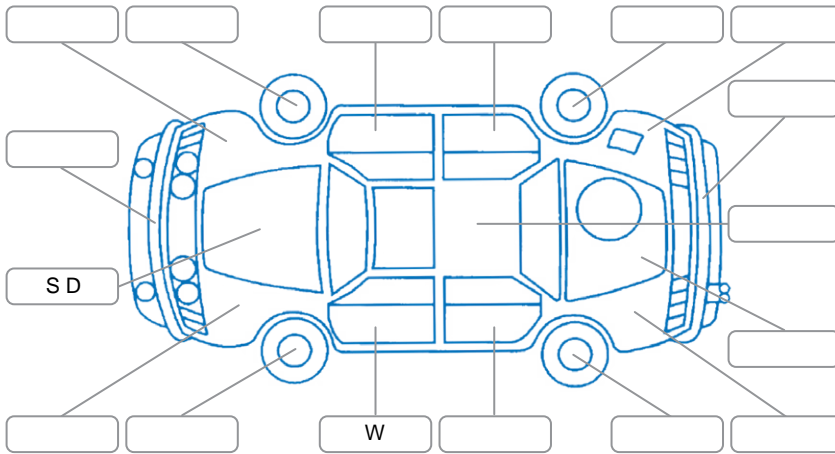
Key
 S = Scratch R = Rust C = Crack * = Decals W = Significant scuffs
 D = Dent PT = Paint defect P = Pin dent SC = Stone Chips

Note: some defects and blemishes may not be displayed in the diagram
