Report ID:	28,290,790	Version:	1
Created:	30 Jun 2026

Make:	LDV	Model:	G10
Body Style:	Van	Year:	2017
Rego No.:	KLB903	Rego Expiry:	12 Mar 2027
WoF Expiry:	09 Jun 2027	Odometer:	108,732 Kms
Good No.:	28290790	VIN:	LSKG4BL1XGA428885
Next Service:	118,712	Service History:	No

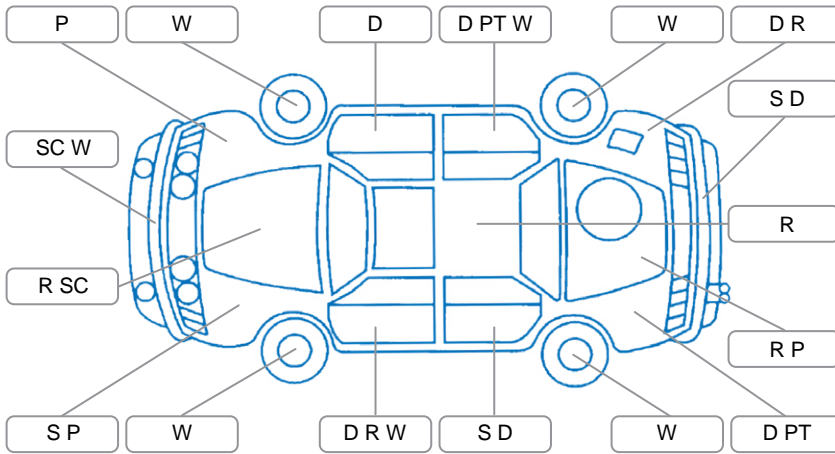
Note: some defects and blemishes may not be displayed in the diagram

- Right sill rust
- Left wing mirror misaligned & scuff
- Left A pillar rust
