| Report ID: | 28,302,743 | Version: | 1 |

| Make: | Mazda | Model: | Premacy |
| Body Style: | SUV | Year: | 2009 |

Body Inspection Comments

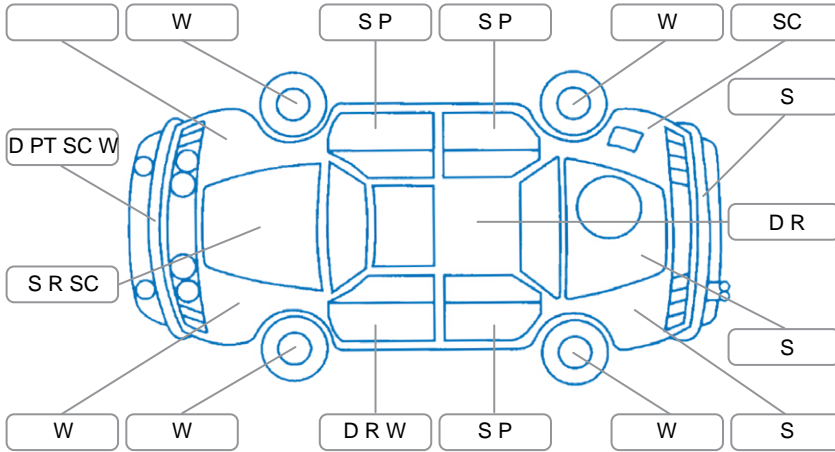
S = Scratch R = Rust C = Crack * = Decals W = Significant scuffs
 D = Dent PT = Paint defect P = Pin dent SC = Stone Chips

Note: some defects and blemishes may not be displayed in the diagram

- Windscreen cracked
- Right auto sliding not operating
- Front bumper misaligned
- Poor paint repairs
