| Make: | Mazda | Model: | MPV |
| Body Style: | SUV | Year: | 2005 |
| Good No.: | 28315527 | VIN: | 7AT0C11EX12446909 |

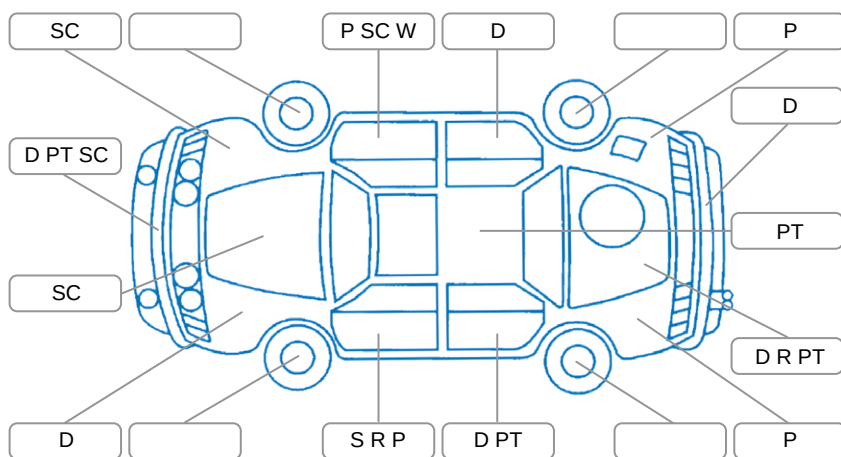
S = Scratch R = Rust C = Crack \* = Decals W = Significant scuffs  
D = Dent PT = Paint defect P = Pin dent SC = Stone Chips

Note: some defects and blemishes may not be displayed in the diagram

Drivers inside door handle broken. Passenger window not closing correctly. Stone chips windscreen. Left side skirt missing.
