| Report ID: | 28,333,327 | Version: | 1 |

| Make: | Toyota | Model: | Estima |
| Body Style: | Wagon | Year: | 2004 |

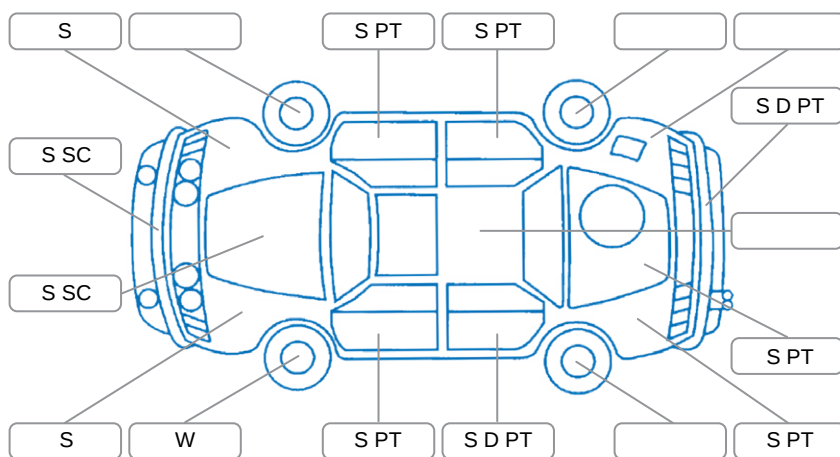
S = Scratch R = Rust C = Crack \* = Decals W = Significant scuffs  
D = Dent PT = Paint defect P = Pin dent SC = Stone Chips

Note: some defects and blemishes may not be displayed in the diagram

Vehicle has ben painted white outside -inner door frames are silver  
RF monsoon shield broken
