| Report ID: | 28,352,185 | Version: | 4 |

| Make: | Mitsubishi | Model: | Eclipse Cross |
| Body Style: | SUV | Year: | 2022 |

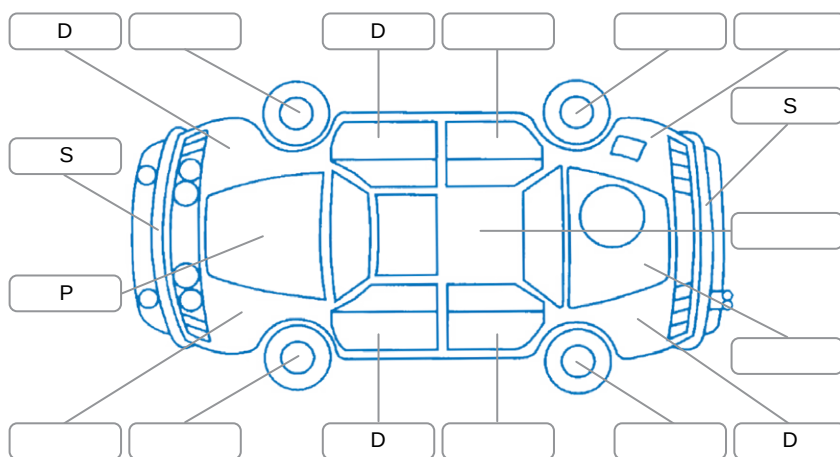
S = Scratch R = Rust C = Crack \* = Decals W = Significant scuffs  
D = Dent PT = Paint defect P = Pin dent SC = Stone Chips

Note: some defects and blemishes may not be displayed in the diagram
