| Report ID: | 28,389,322 | Version: | 1 |

| Make: | Mitsubishi | Model: | Galant |
| Body Style: | Sedan | Year: | 2007 |

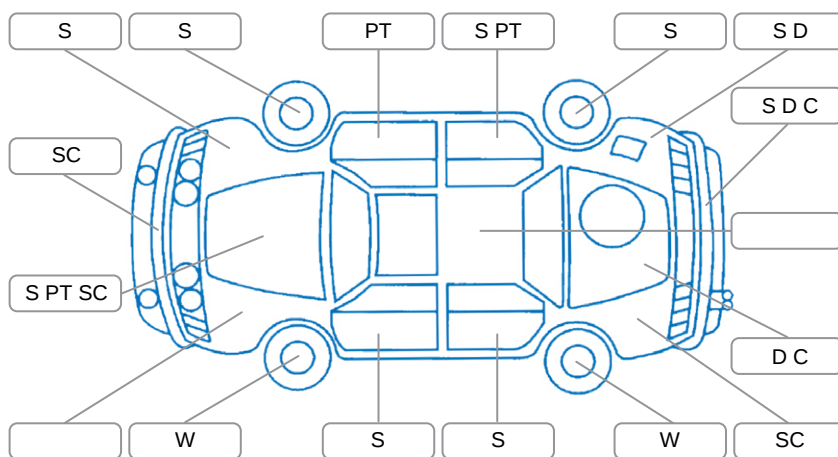
S = Scratch R = Rust C = Crack \* = Decals W = Significant scuffs  
D = Dent PT = Paint defect P = Pin dent SC = Stone Chips

Note: some defects and blemishes may not be displayed in the diagram

L sunshade mirror cover missing,FR seat torn,both front and rear center seat belt damaged,FR side carpet torn,FR door seal torn,both wing mirror folding faulty,FB damage ,antenna damaged,tailgate bent,RL interior door panel torn,
