| Report ID: | 28,408,760 | Version: | 2 |

| Make: | Nissan | Model: | Latio |
| Body Style: | Sedan | Year: | 2014 |

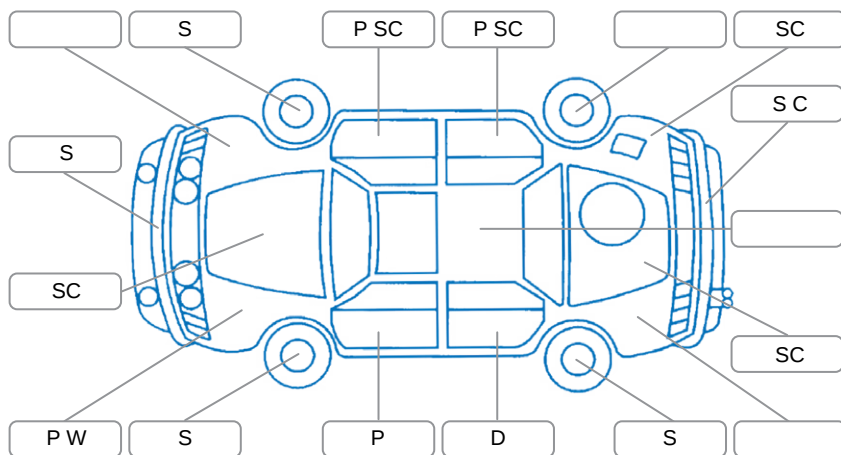
Note: some defects and blemishes may not be displayed in the diagram

RR taillight cracked. Headlights faded.  
Boot lid panel beginning to rust.  
Boot area by spare wheel filled with water and rust.  
Windscreen chipped inside cva.
