| Report ID: | 28,416,347 | Version: | 2 |

| Make: | Toyota | Model: | Hiace |
| Body Style: | Van | Year: | 2013 |

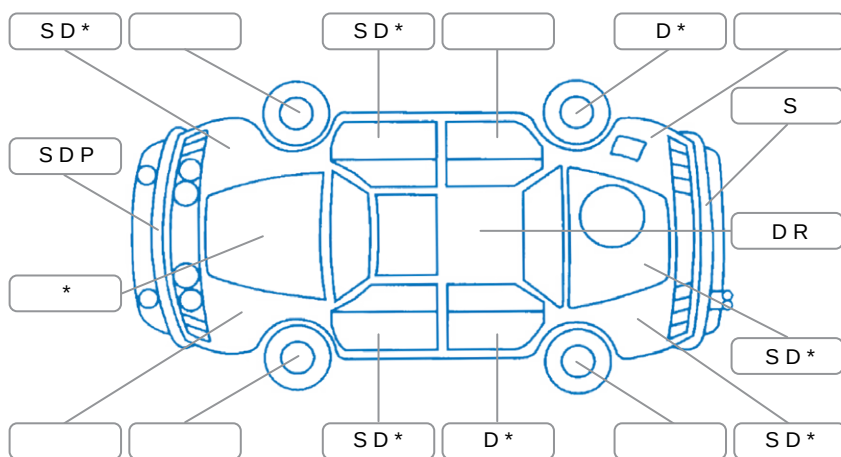
Note: some defects and blemishes may not be displayed in the diagram

Rear bumper damage, r brake light cracked, rear bumper torn, interior tail gate rust and dent, number plate not working, both front tyre side wall cracked, r rear tyre cracked, engine oil leak, both front wheel play.
