| Report ID: | 28,434,278 | Version: | 1 |

| Make: | Mazda | Model: | Atenza |
| Body Style: | Sedan | Year: | 2006 |

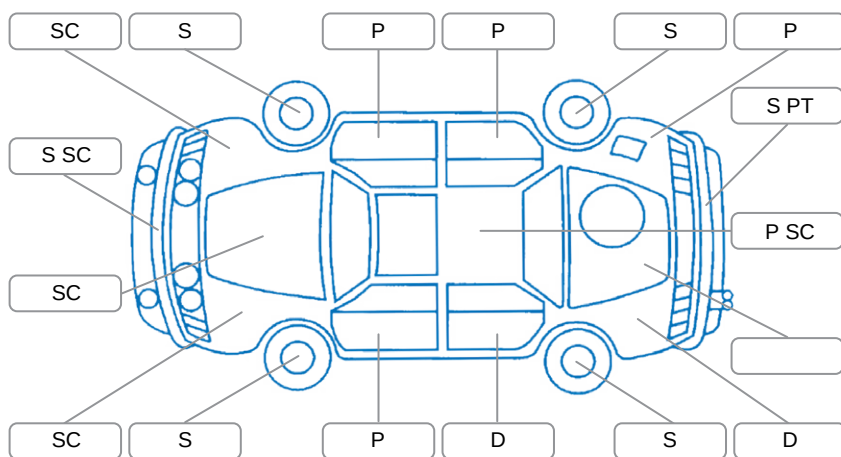
Note: some defects and blemishes may not be displayed in the diagram

Rear tail lights are tinted. Right rear monsoon shield broken.
