| Make: | Mitsubishi | Model: | Outlander |
| Body Style: | SUV | Year: | 2007 |
| Rego No.: | HLM437 | Rego Expiry: | 25 Nov 2026 |
| Good No.: | 28510358 | VIN: | JMYXTCW5W7Z001217 |

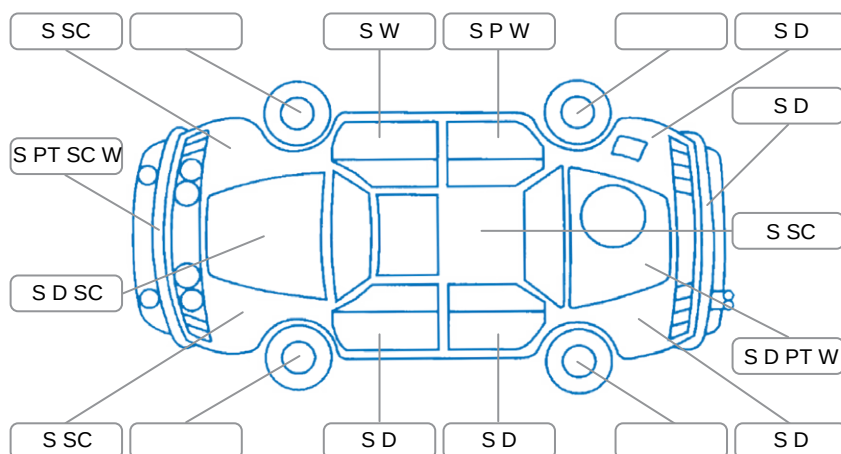
S = Scratch    R = Rust    C = Crack    \* = Decals    W = Significant scuffs  
D = Dent    PT = Paint defect    P = Pin dent    SC = Stone Chips

Note: some defects and blemishes may not be displayed in the diagram

Water in right tail light. left exterior window rubber torn.
