| Report ID: | 28,525,336 | Version: | 1 |

| Make: | Subaru | Model: | Legacy |
| Body Style: | Wagon | Year: | 2006 |

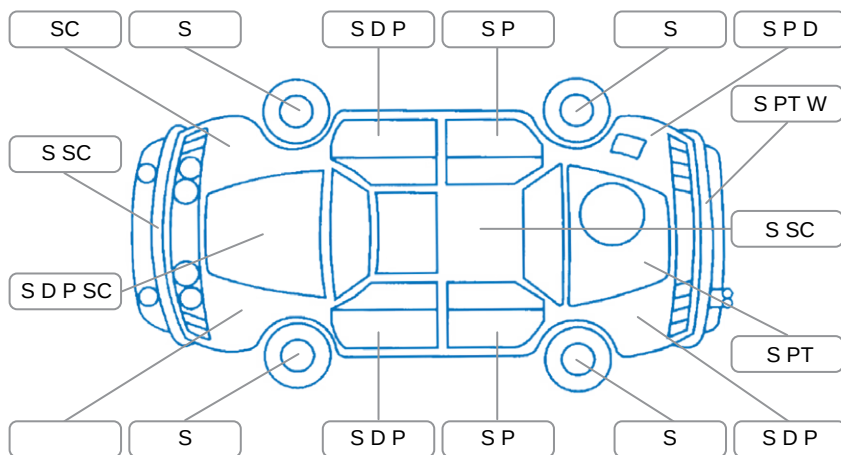
Note: some defects and blemishes may not be displayed in the diagram

Crack in right side wing mirror indicator repeater lens. Inside & outside edges worn very low on left front tyre, also cracks on inner side wall of tyre & a cut on side wall on outside of tyre.
